Manhole Inspection Summary

Manhole # S08YY1004MH

Insp Date: **6/30/06 6:57 AM**

Location Address: **4175 CREST HEIGHTS RD**

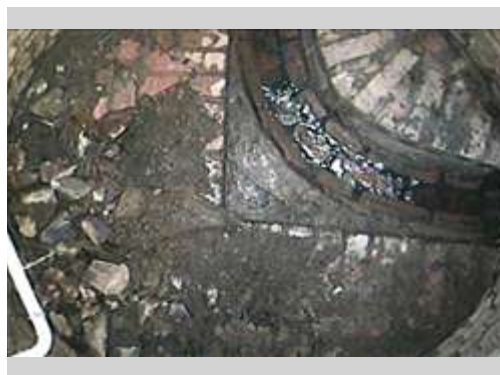
Top View

Evidence of surcharge - Bench debris.

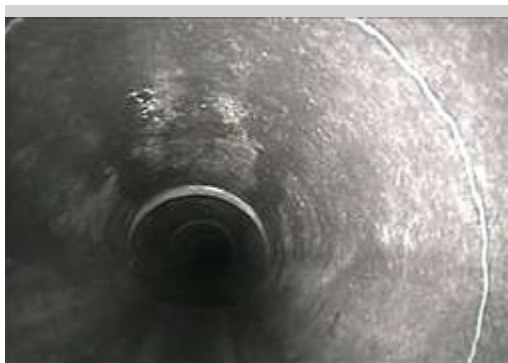
Inside the I3

Comments **The I3 pipe seal is not flush to the pipe.**

Offset joint.

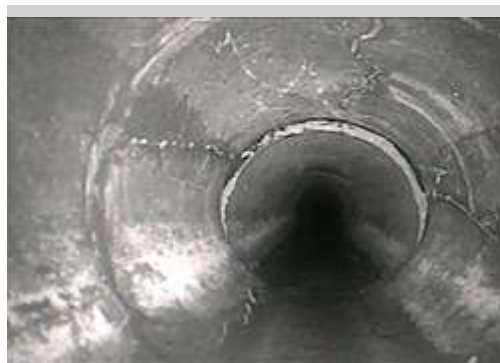
Inside the O12

Offset joint.

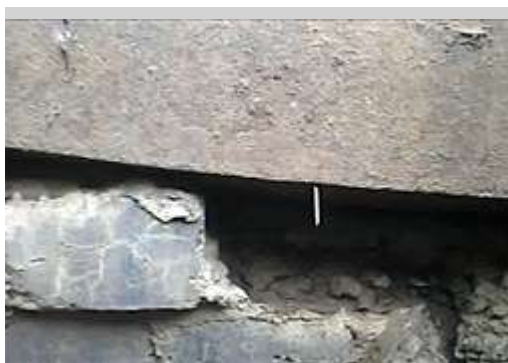
Defect

Frame leaks. Adjustment deterioration, loose brick, and infiltration.

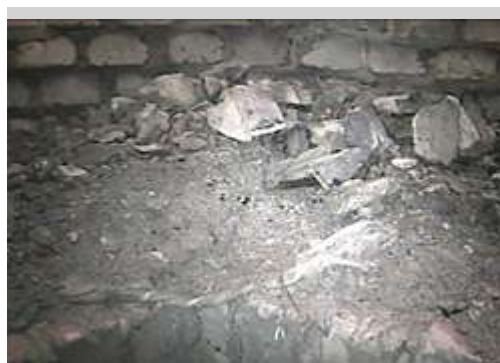
Defect

Barrel deterioration and infiltration. Bench debris

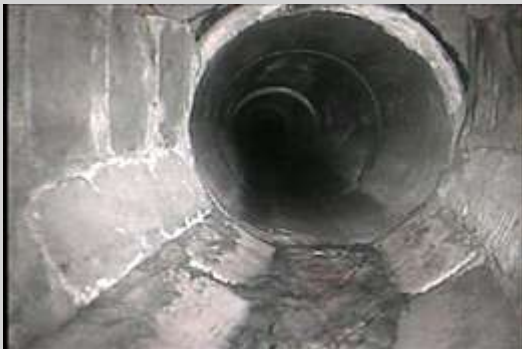
8 in. Circular Gravity Sewer Pipe In @ 3 O'Clock

Infiltration: **Evidence** Pipe Seal Cond: **Unknown**
